General Information V8 engines, What to expect.

General V8 Engine information

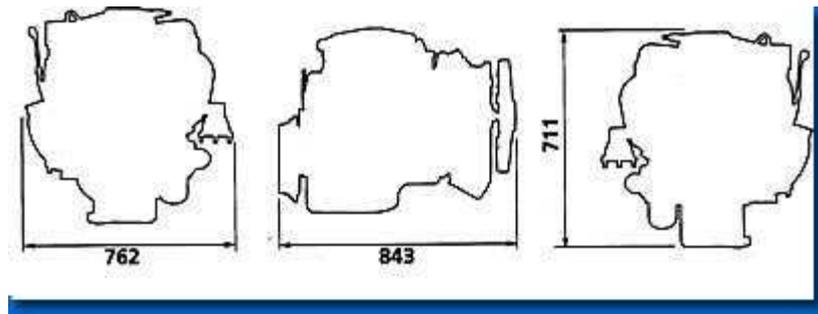
Dimensions of the Rover V8 engine fully dressed, and weighing in at 230KG all up.

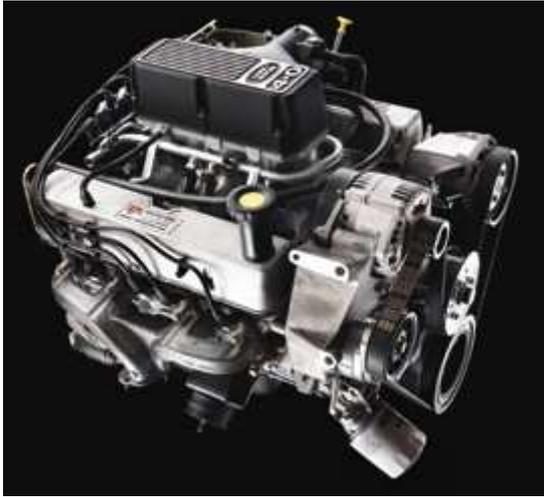
Gems - Sagem injection

Although there have been a few variants in the V8 engine's injection systems over the years, none were so dramatic as the changes made in or around 1999. I am talking about Motronic injection. You can see in this picture a conventional style injection system with the square type plenum chamber.

This one is Gems (Sagem) injection, and looks the most familiar as it is pretty much the same at hardware level as its injected predecessors; 'Hot wire' and 'Flapper' style injection systems.

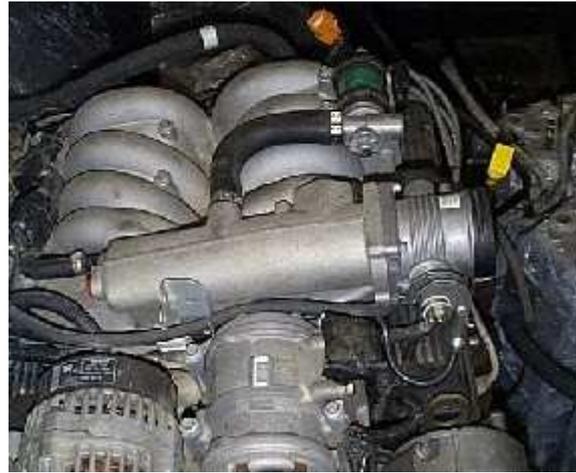
Thor - Motronic

As you can see from this picture of the Thor (Motronic) injected engine, the intake system is now looking completely different, incorporating 8 tubular style intake runners rather than the square plenum type shown above.

This intake was supposed to offer far greater torque, which indeed it does.

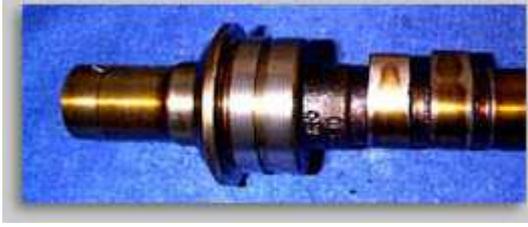
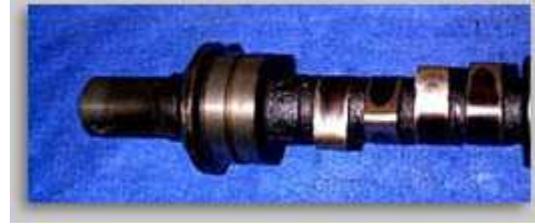
Longer engine life, increased engine efficiency, smooth idle and good power, cannot be expected from cams that look like this (and it is not an uncommon sight).

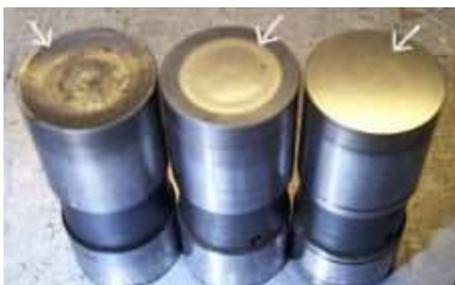
These three tappets have only done 5,000 miles on the TVR engine they were fitted to. They tell a story from left to right, it's not looking good.

The left hand tappet shows it is completely worn out and after only 5,000 miles it was the worst one on the engine. As expected, it corresponded to the camshaft lobe that was most worn (probably the one that was the cause of the tappet noise in the first instance).

The middle tappet is also quite dished and this was going to be the next one to become a major issue soon.

The right hand tappet shows the signs of wear (rounded indentation expanding from the centre) all other tappets on this engine at only 5,000 miles were showing signs of bad wear, and the three depicted above represent the extremes and average condition of what we found and what you could expect.

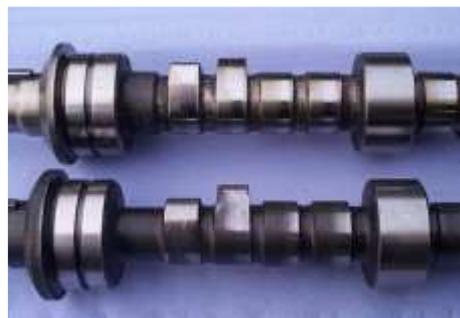
Comparing Cams: Top, at 35,000 miles and no sign of wear, the Morgan cam is still looking good.

Below, this cam did not take to its new tappets, so it was bad then, and worse now.

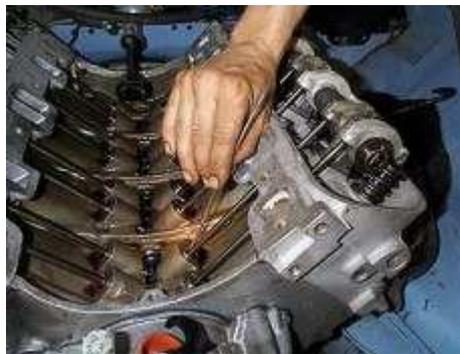
Checking tappet pre-load can be quite difficult and, as there are no special tools as yet available for it, you will need to select varying sizes of welding rod, or fabricate your own.

The allowed tolerance is 20-50 thou. which is the distance measured between the top of the tappet's piston and the retaining circlip. Each one needs checking individually with the cam ideally 108 deg. off its lobe.

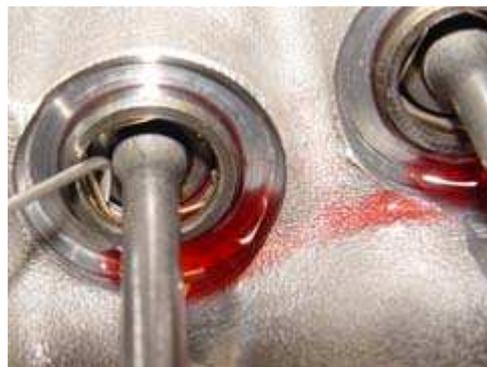
Nicely oiled with cam shaft lube (the red stuff)

To create your own tool, all you need is a welding rod and a suitable device to measure it with. This rod is 60 thou, your best bet is to create 2 rods, one at 20-30 thou. and the other at 50-60 thou. This will tell you if your tappets are out of the allowed tolerance, more rods will be needed to judge what size shims to fit.

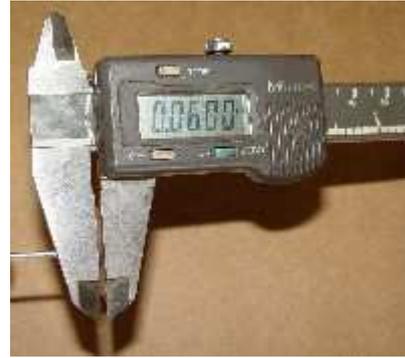
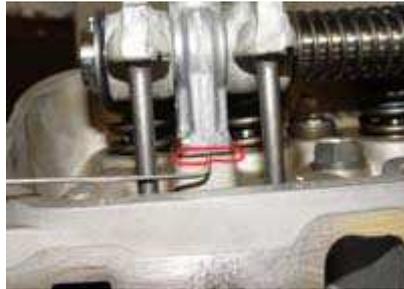
Once you have ascertained the measure of the tappets, pre-load adjustment is achieved by fitting special pre-load shims under the pedestals. But beware, the rocker ratio is 1.6 that of the clearance that needs correcting, so a 16 thou. shim will make approx 25 thou. difference.

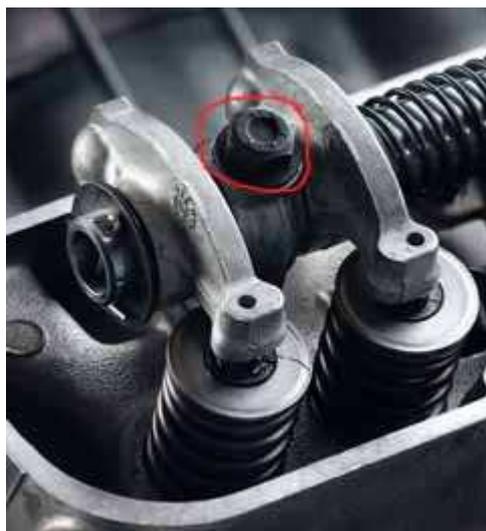
To attach the shims, you need to slacken all 8 of the 14mm bolts.

Then, one bolt at a time, nearly remove them so you can slide the shim underneath, then slightly tighten the bolt so nothing slips or slides. Do this for all 8 rockers.

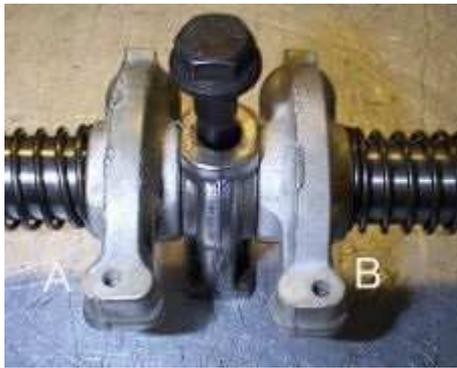
These bearings are your worst nightmare. Any sign of copper means you need to do something quick.

Often closer inspection will show hair line cracks, don't ignore them, as this is what you can expect.

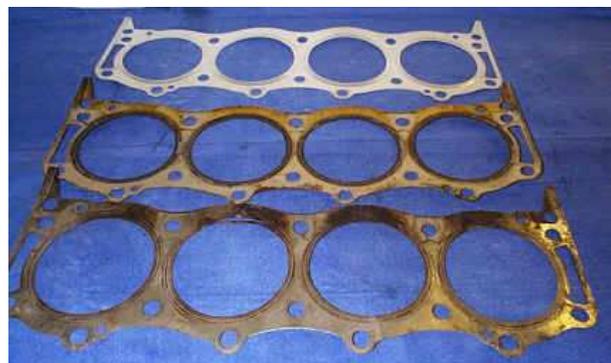
From top:

1. New head Gasket, (can't fault it)
2. Head gasket after 50,000(ish) miles, notice the upper edge is showing a high degree of discoloration whilst looking good on the lower edge, and no blows but obvious leakage from all cylinders.
3. As 2, but the leakage is so severe the gasket is breaking up. and allowing compression to leak into the oil and water jackets.

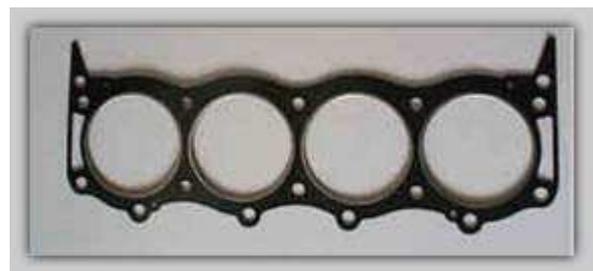
One solution (but it lowers compression ratio) the composite type head gasket.

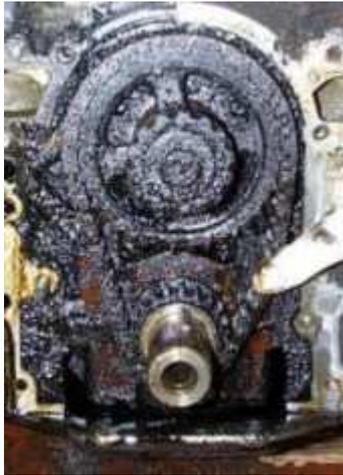
Stock Timing Gear

This rather weedy looking thing is the stock Rover timing chain set, unchanged for the past 30 years. One major problem it suffers from is stretching, and a stretched timing chain will cause significant problems with advance and retard under acceleration and deceleration to both cam and ignition timing. Most are badly stretched, but higher mileage engines will have a major problem in this area.

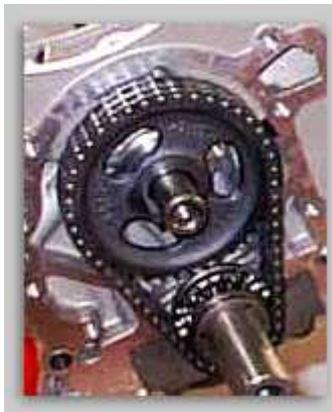
And this is what they so often get like.

In this picture you can't see the stretch, but you sure can see how tolerant the V8 is, this engine had been (like most) running for many thousand miles in this condition before it finally died.

This is what so often happens when you leave things until they go bang, it costs so much more to correct it this late, and the results may be less than that of rebuilding a cleaner engine.

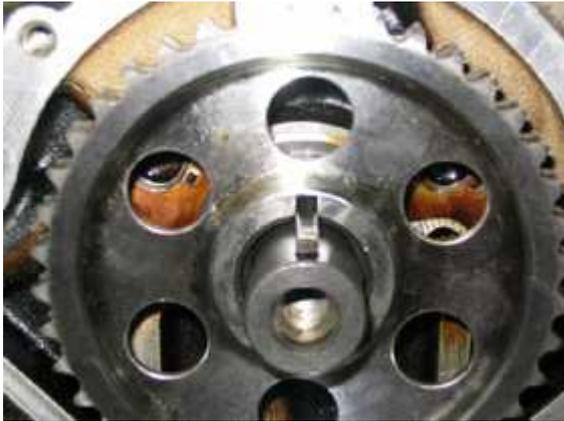
You may notice that the new JP timing chain set employs a deeper machined journal for the woodruff key location, of the pulley (shown here without the chain). Thus it has come to our attention that this may cause concern and we would like to offer the following advice.

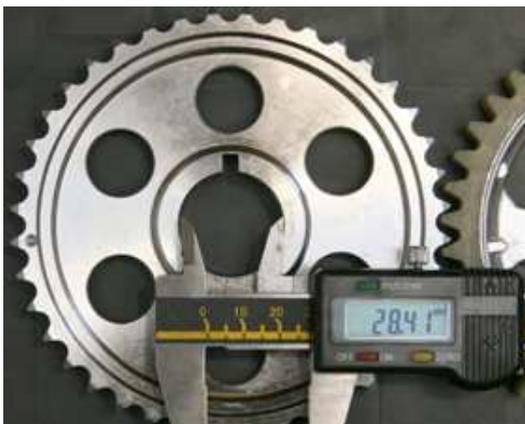
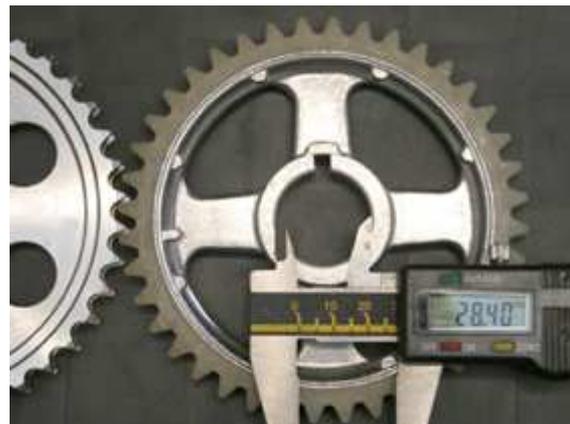
With image one and two shown below, you will notice that the internal size of the 2 pulleys, original and J&P, are almost exactly the same. Therefore the original key will protrude into the machined slot by the same amount, and thus for this scenario is not a problem.

Although the front appearance of the keyway slot is bigger with the JP timing wheel the advantage of this allows for a far greater oil feed through the woodruff key slot to enable increased lubrication to the distributor drive gear. As you can see in picture 2 below, the oil has a much larger area to flow into, even when the angle of the woodruff key restricts it on the normal key way set up.

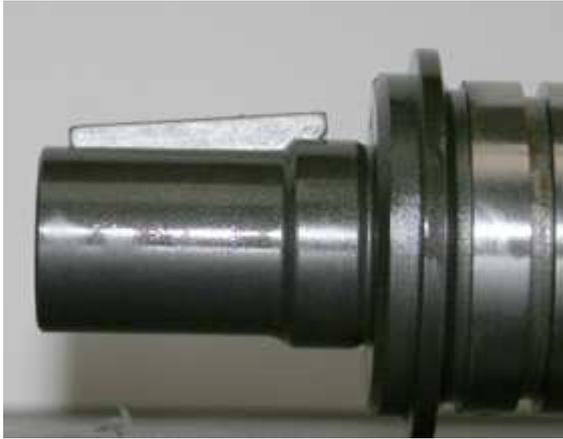
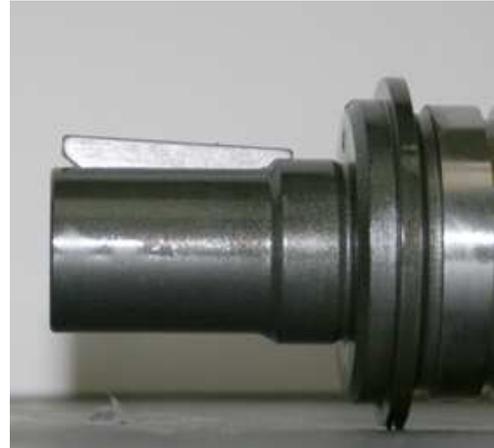
Above, shown here you can see the true location between woodruff key and camshaft. As you will notice in picture A, when located, the woodruff key will actually have far greater contact with the timing wheel location, as the woodruff key will actually sit at this angle when installed, thus making the woodruff key appear to have only small contact. But as you can imagine, the contact area is significantly increased along the length of the woodruff key.

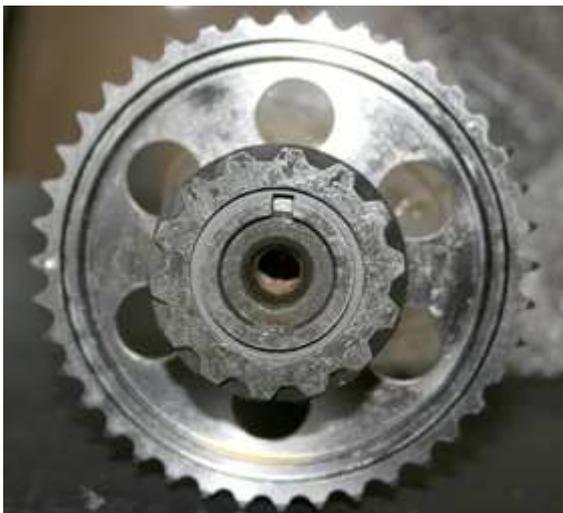
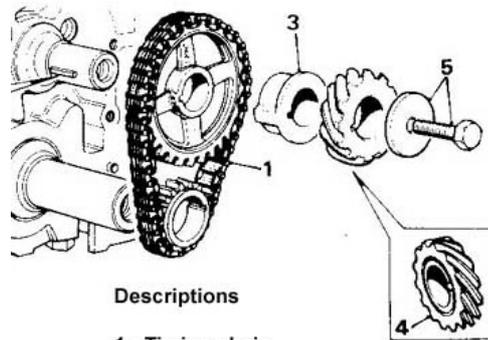
Descriptions

- 1 - Timing chain
- 2 - Camshaft key parallel
- 3 - Distance piece
- 4 - Distributor drive gear
- 5 - Retaining bolt and washer

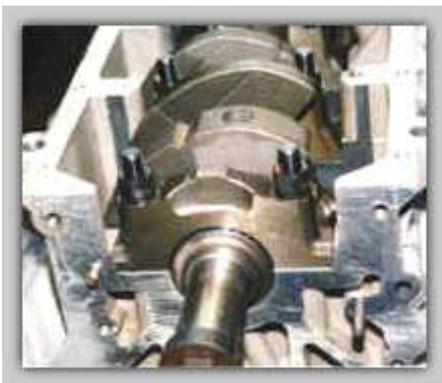
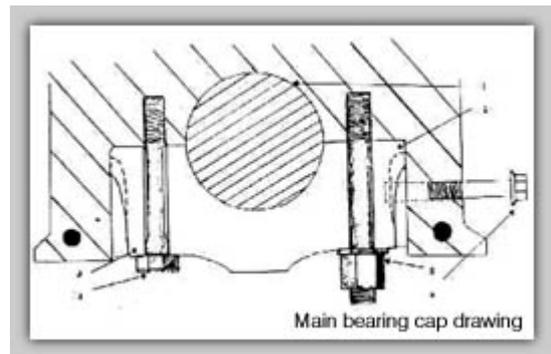
Main bearing stud kit installed on an '87 block, torqued down to 90 ft./lb (std bolts 55 ft./lb.) ensures the best possible engine strength.

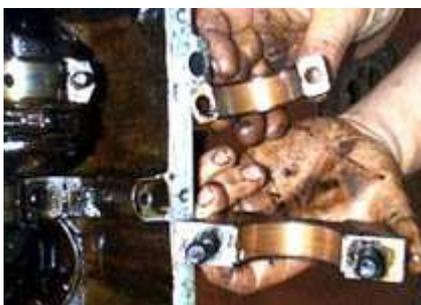
These bearing are your worst nightmare. Any sign of copper means you need to do something quick.

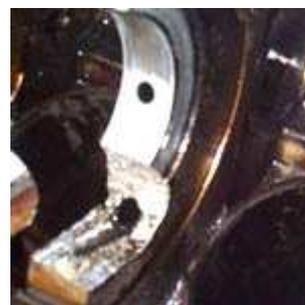
Often, closer inspection will show hair line cracks. Don't ignore them, as this is what you an expect.

All later (post '96) Rover engines have fully enclosed main bearing caps, (you will see from the picture on the left that the main bearing cap has no contact with the engine block).

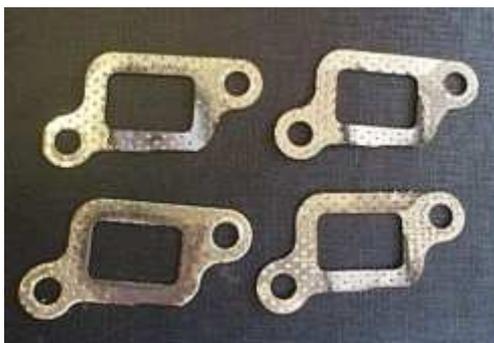
▲ Although it may seem obvious, which way round you fit the exhaust gaskets, it is very possible to get it wrong, We strongly suggest you check [& double check] the correct alignment as the following 2 pictures will show, getting it wrong has serious power loss implications.

It's clear to see **just how wrong things can be**. The problem is not 'the wrong way round', but 'inside out & the wrong way round'!

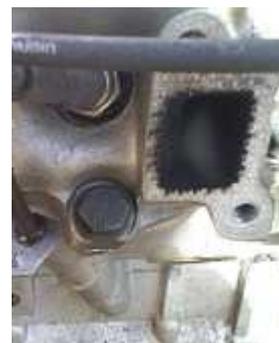
Surprisingly enough, exhaust blow was not a problem but power was 40% down (minimum), especially as rpm. increased.

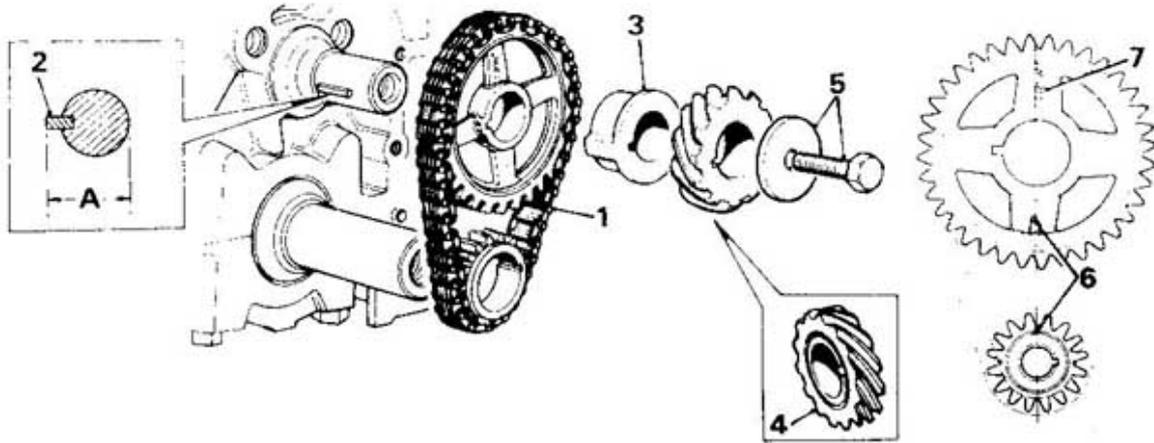
q Timing chain removal and refitting ▲TOP

- 1 - Timing chain
- 2 - Camshaft key parallel
- 3 - Distance piece
- 4 - Distributor drive gear
- 5 - Retaining bolt and washer
- 6 - Timing marks
- 7 - 'FRONT' marking

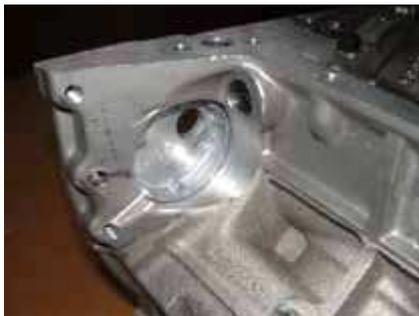
The old blanking plug has a hole in it for the crank angle sensor that the GEM's engine management system uses.

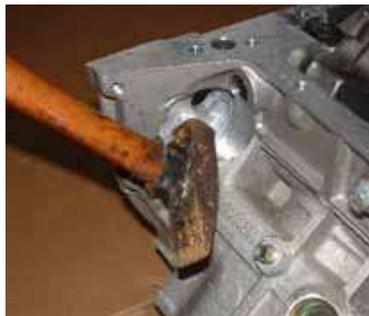
This has to be removed for our blanking plug to be fitted. Removal of this is very easy, a small tap with a hammer will knock the old plug out.

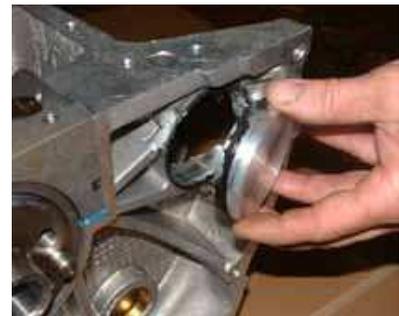
The blanking plug that we supply fits in place of the original and just needs some silicon to ensure it stays in place.

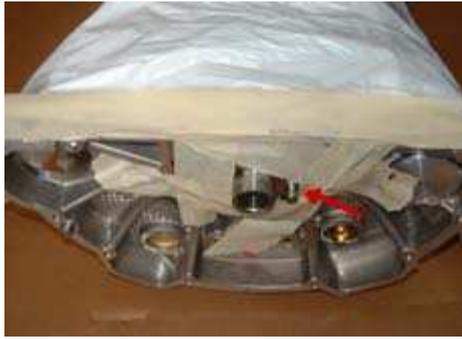
The dowel in the end of the crank shaft has to be removed to enable the flywheel to fit correctly. You should ensure that the crank seal is completely covered, and also the bottom end of the engine, so that no swarf can contaminate it.

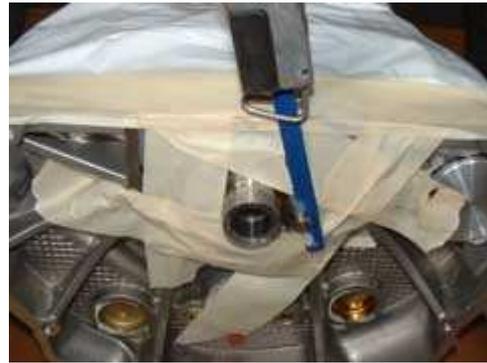
Using a hacksaw (or air hacksaw as seen here) the dowel has to be cut off as flush to the end of the crank as possible.

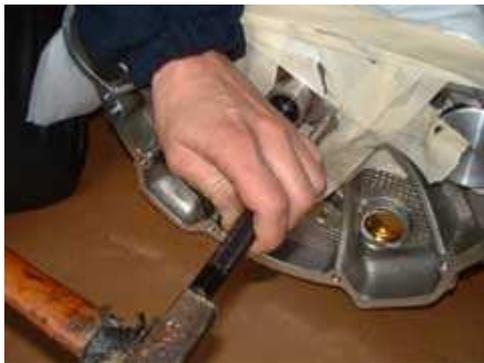
A centre punch is then required just to knock what remains of the dowel into the hole so that it does not protrude from the face as seen in the next picture.

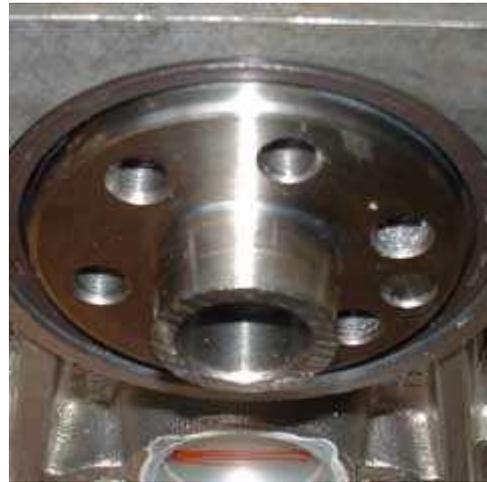
As seen here the dowel has been cut off and then punched back into the end of the crank so that there is no chance that it can interfere with the flywheel.

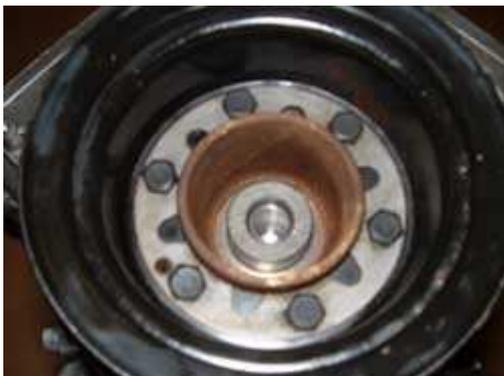
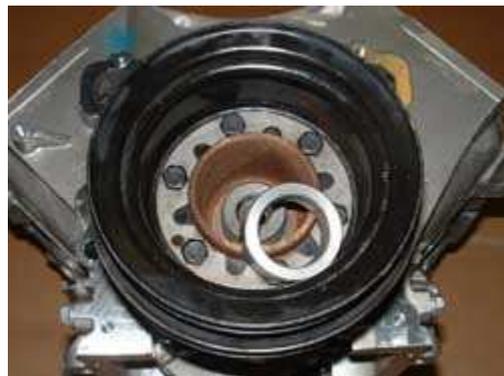
The crank is slightly longer, which means that when you do up the front pulley bolt, it would not actually come into contact with the pulley and therefore the pulley will be loose.

As you can see here we have made a spacer that fits over the crank end. Now, when the pulley bolt is tightened, everything is pulled together as it should be.

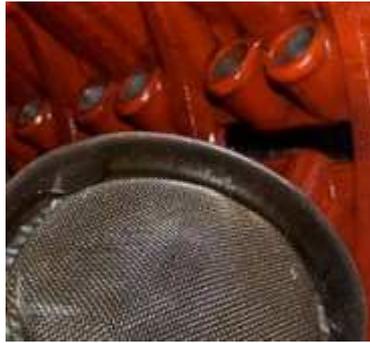
The strainer is showing the red paint blockage, this engine failed completely within 20 miles

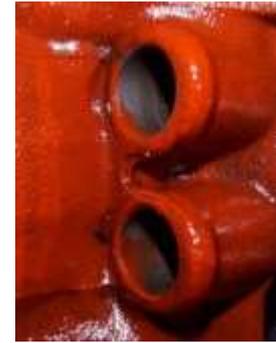
Close up of the strainer shows the red paint blockage

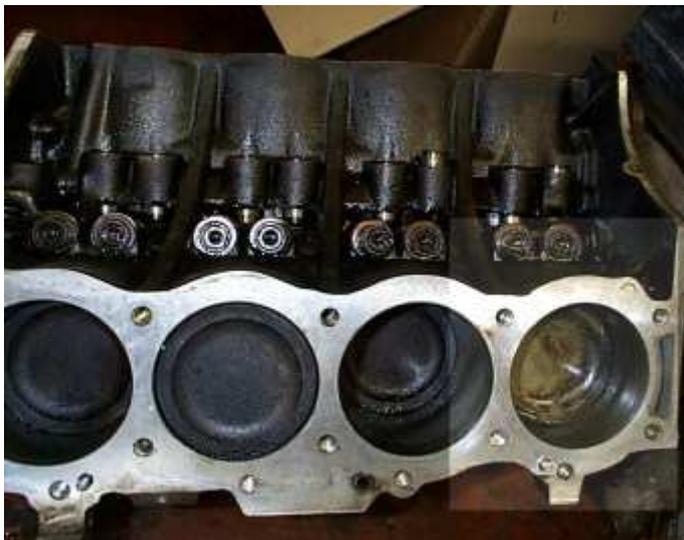
It's no coincidence that the Piston on the right (no 7) seems to have been '**steam. cleaned**'

This is a sure sign of the cylinder block being cracked somewhere behind it. In many cases such as this one you will also find that the cylinder liner has moved down the bore slightly. The problem with this engine had been wrongly diagnosed by the main agent (at a cost of £600.00) as a 4 thou. warp in the centre of the head.
